TAMU Project

**Energy Consumption Data Quality Assurance/Quality
Control Assessment Report for the
Month of October 2016**

**Utility & Energy Services
Division of Administration
Texas A&M University**

November 2016

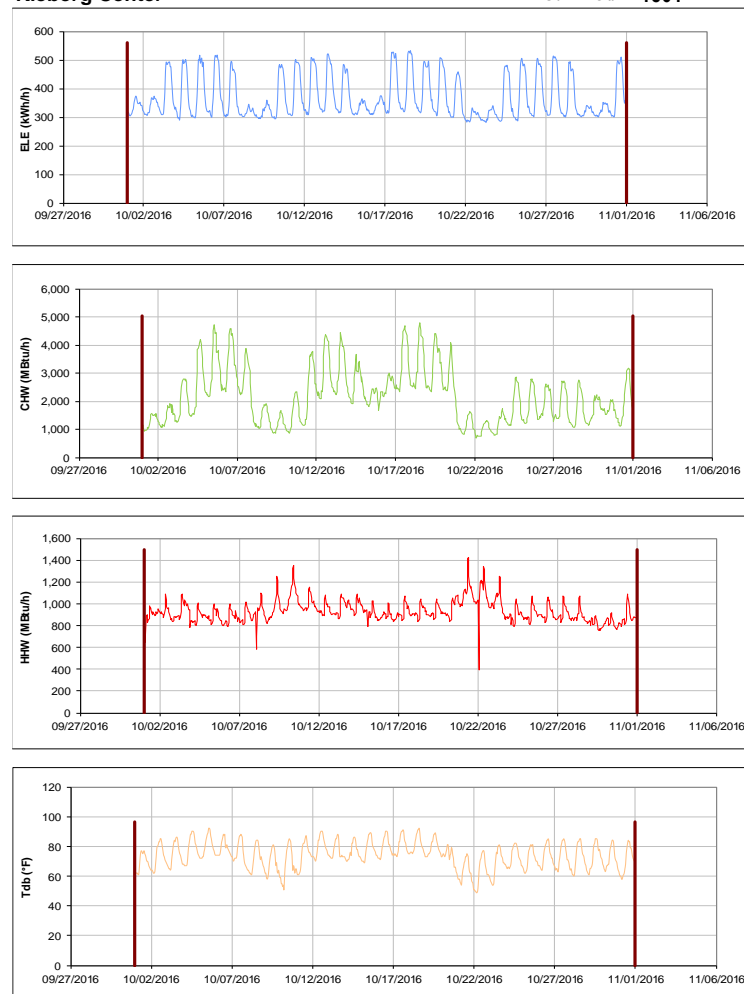
TAMU / BLDG #: 1501

Figure III-148 Hourly Whole Building Electricity, Chilled Water, and Hot Water Consumption for Kleberg Center during the Month of October 2016 and the Corresponding Hourly Outdoor Dry Bulb Temperature for College Station, TX

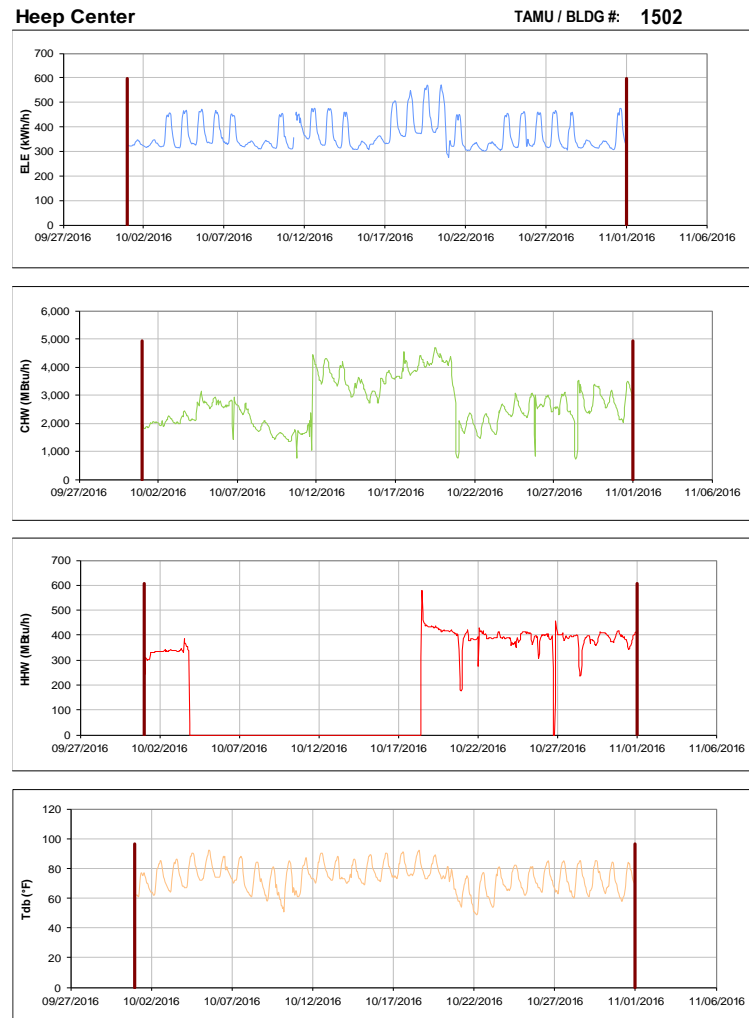
Figure III-149 Hourly Whole Building Electricity, Chilled Water, and Hot Water Consumption for Heep Center during the Month of October 2016 and the Corresponding Hourly Outdoor Dry Bulb Temperature for College Station, TX

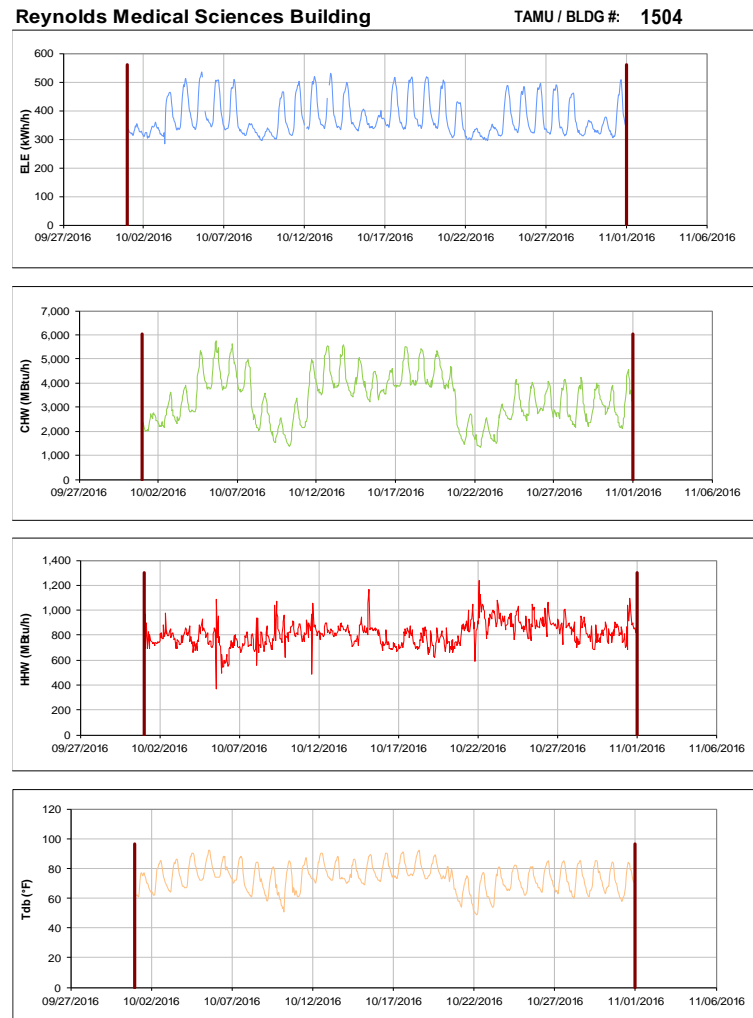
Figure III-151 Hourly Whole Building Electricity, Chilled Water, and Hot Water Consumption for Reynolds Medical Sciences Building during the Month of October 2016 and the Corresponding Hourly Outdoor Dry Bulb Temperature for College Station, TX

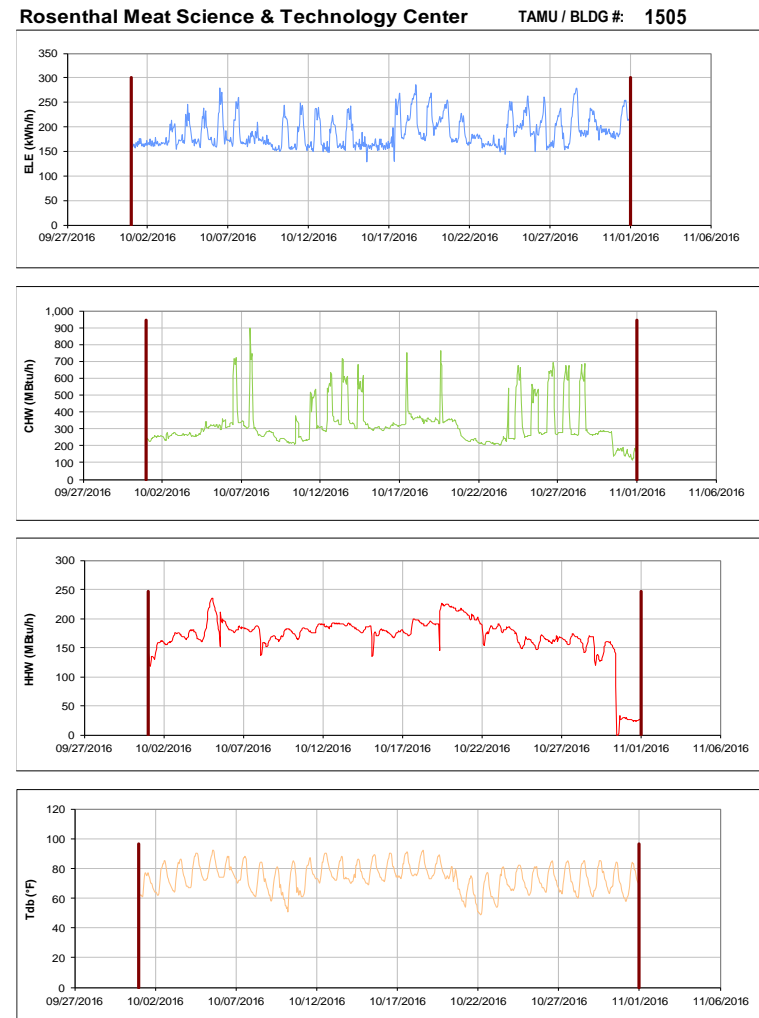
Figure III-152 Hourly Whole Building Electricity, Chilled Water, and Hot Water Consumption for Rosenthal Meat Science & Technology Center during the Month of October 2016 and the Corresponding Hourly Outdoor Dry Bulb Temperature for College Station, TX

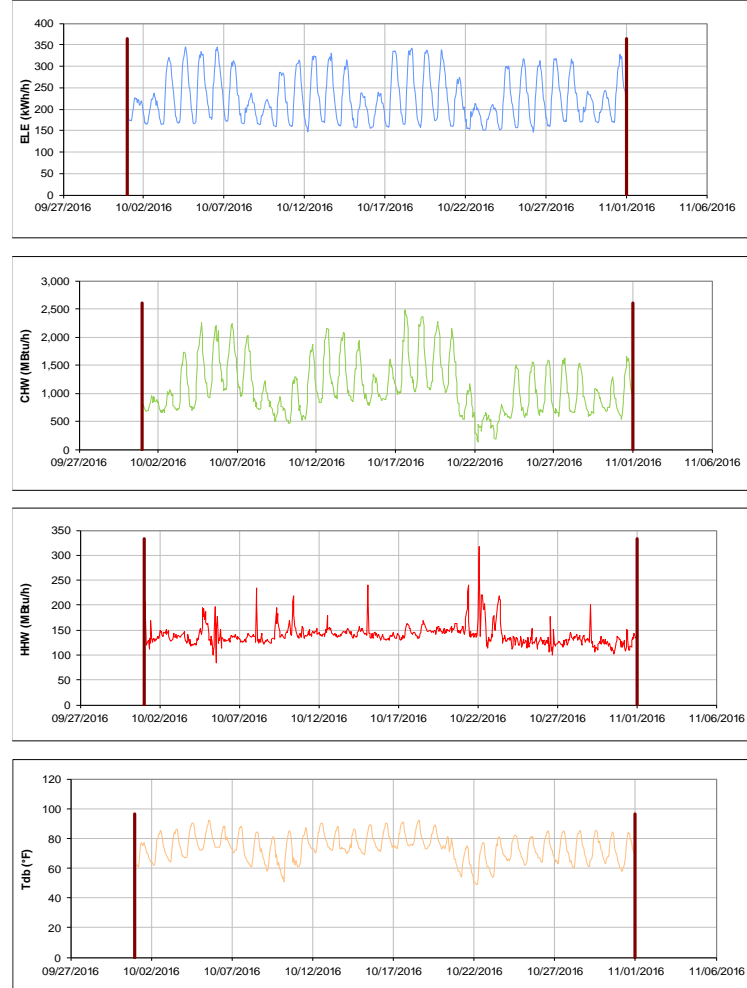
TAMU / BLDG #: 1506

Figure III-153 Hourly Whole Building Electricity, Chilled Water, and Hot Water Consumption for Horticulture-Forest Science Building during the Month of October 2016 and the Corresponding Hourly Outdoor Dry Bulb Temperature for College Station, TX

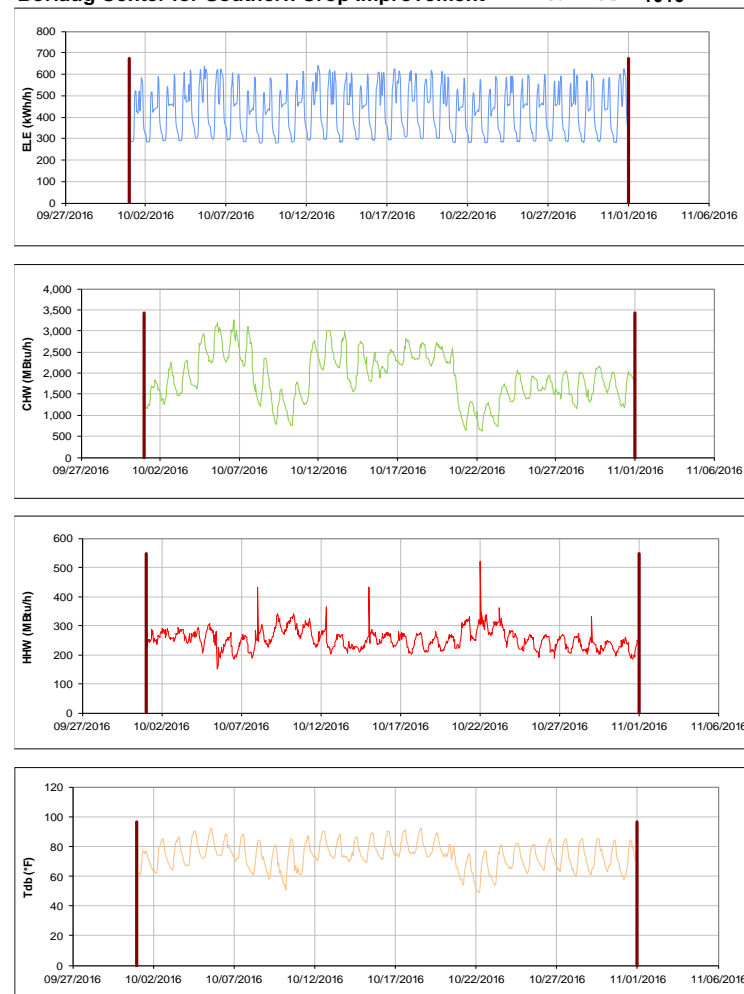
TAMU / BLDG #: 1513

Figure III-160 Hourly Whole Building Electricity, Chilled Water, and Hot Water Consumption for Borlaug Center for Southern Crop Improvement during the Month of October 2016 and the Corresponding Hourly Outdoor Dry Bulb Temperature for College Station, TX

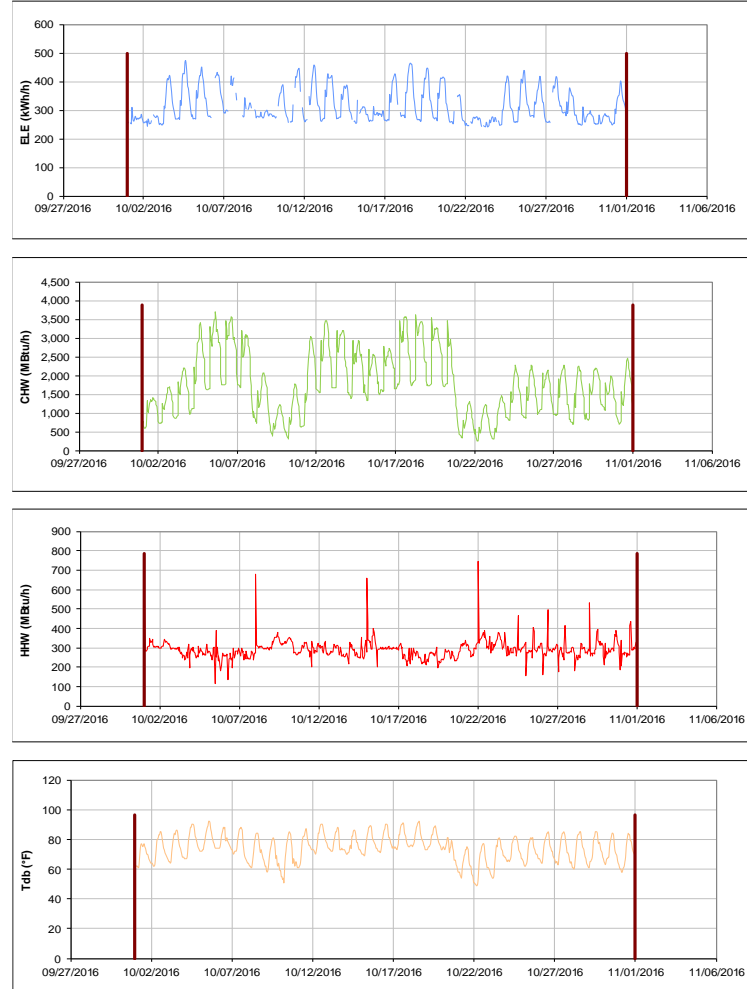
TAMU / BLDG #: 1518

Figure III-161 Hourly Whole Building Electricity, Chilled Water, and Hot Water Consumption for TX School of Rural Public Health during the Month of October 2016 and the Corresponding Hourly Outdoor Dry Bulb Temperature for College Station, TX

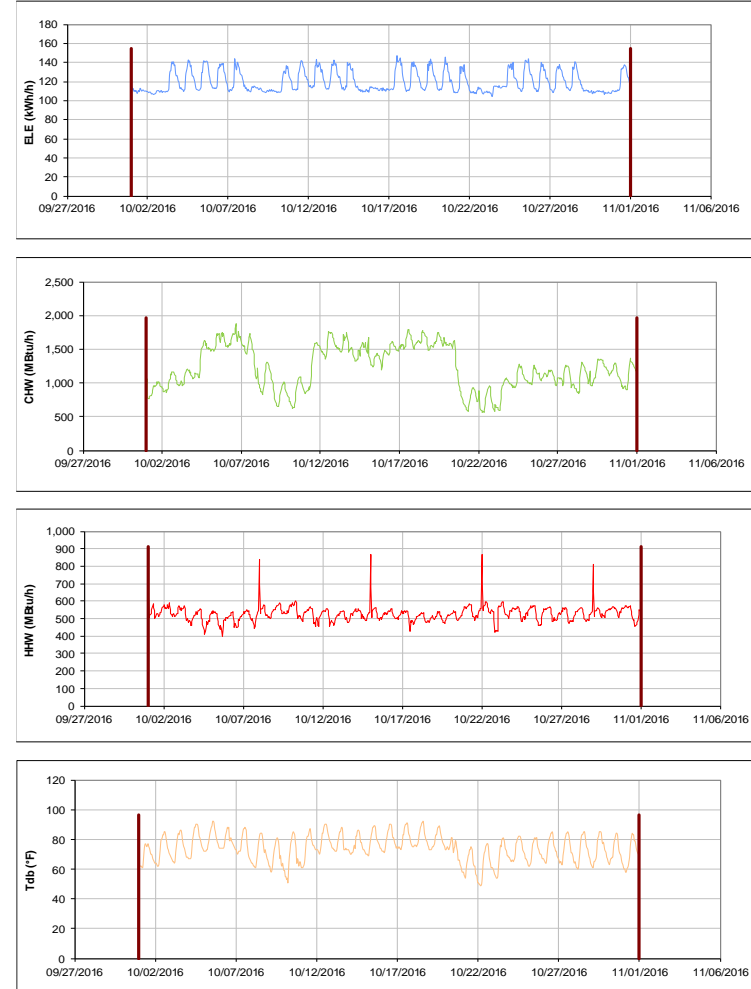
TAMU / BLDG #: 1525

Figure III-162 Hourly Whole Building Electricity, Chilled Water, and Hot Water Consumption for Nuclear Magnetic Resonance Facility during the Month of October 2016 and the Corresponding Hourly Outdoor Dry Bulb Temperature for College Station, TX

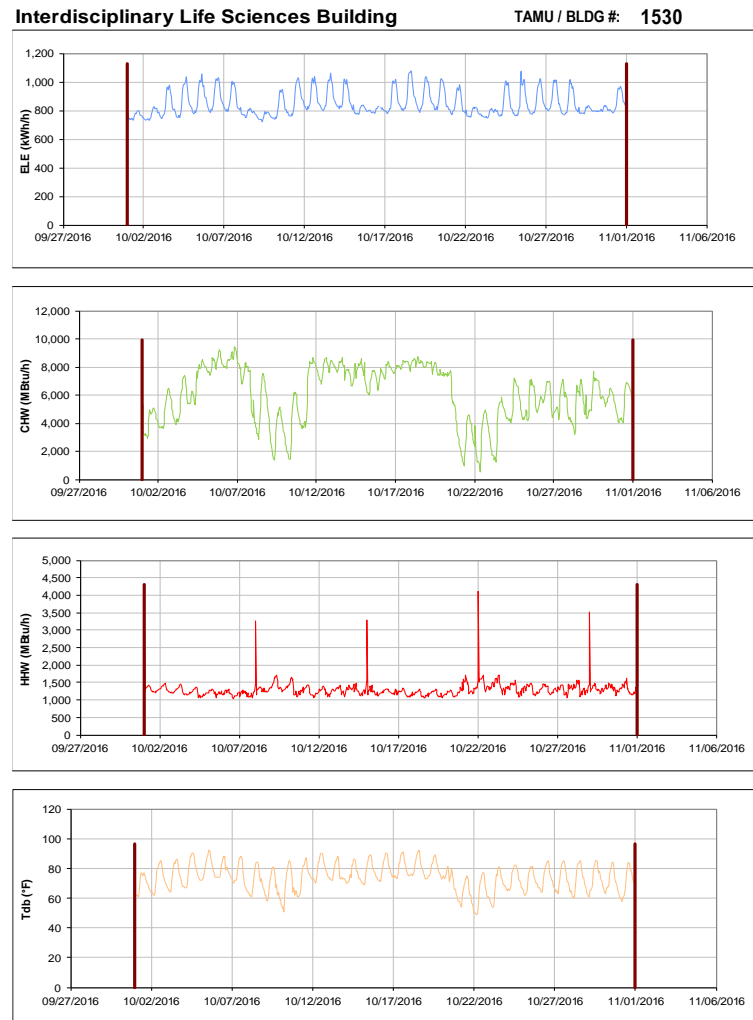
Figure III-163 Hourly Whole Building Electricity, Chilled Water, and Hot Water Consumption for Interdisciplinary Life Sciences Building during the Month of October 2016 and the Corresponding Hourly Outdoor Dry Bulb Temperature for College Station, TX

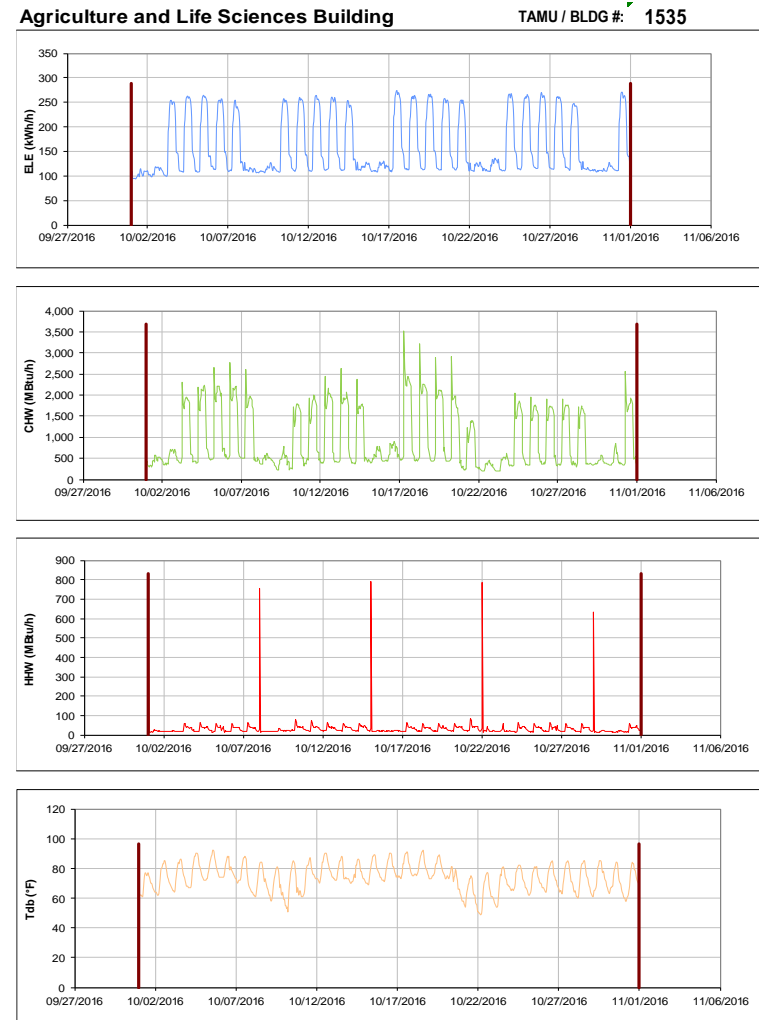
Figure III-164 Hourly Whole Building Electricity, Chilled Water, and Hot Water Consumption for Agriculture and Life Sciences Building during the Month of October 2016 and the Corresponding Hourly Outdoor Dry Bulb Temperature for College Station, TX

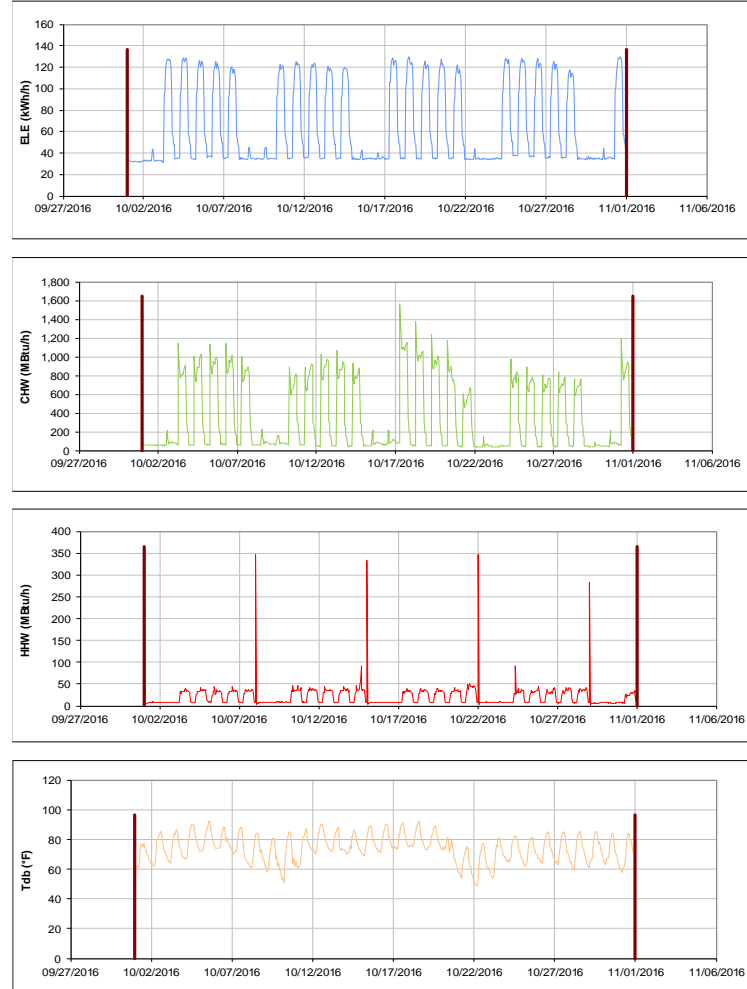
TAMU / BLDG #: 1536

Figure III-165 Hourly Whole Building Electricity, Chilled Water, and Hot Water Consumption for AgriLife Services Building during the Month of October 2016 and the Corresponding Hourly Outdoor Dry Bulb Temperature for College Station, TX

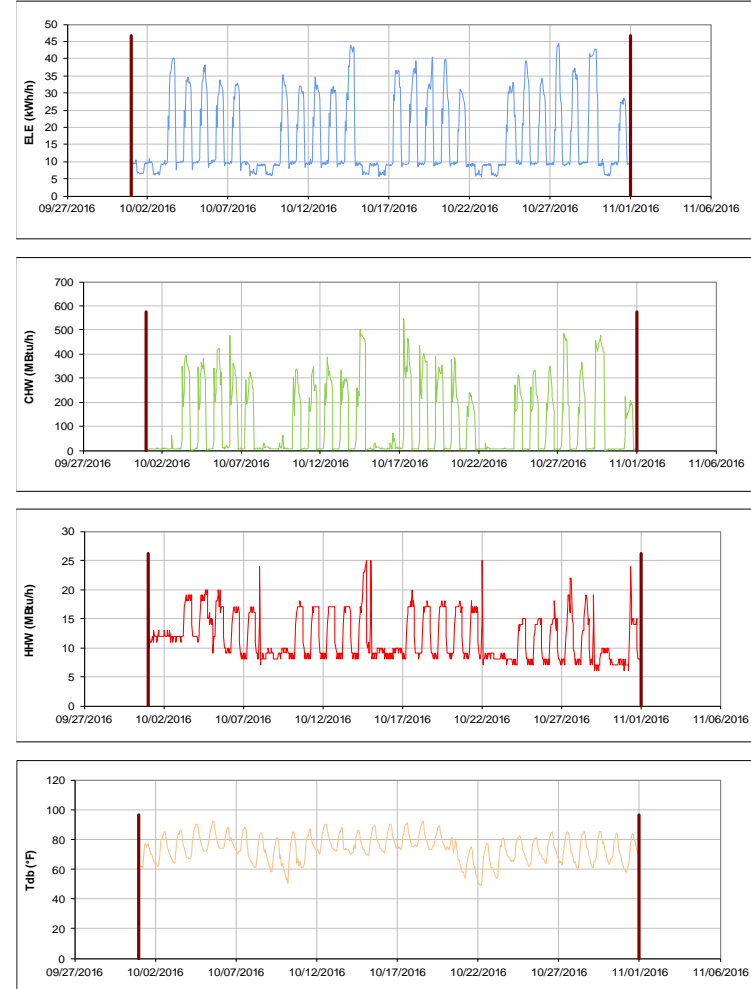
TAMU / BLDG #: 1538

Figure III-166 Hourly Whole Building Electricity, Chilled Water, and Hot Water Consumption for Agriculture Program Visitors Center during the Month of October 2016 and the Corresponding Hourly Outdoor Dry Bulb Temperature for College Station, TX

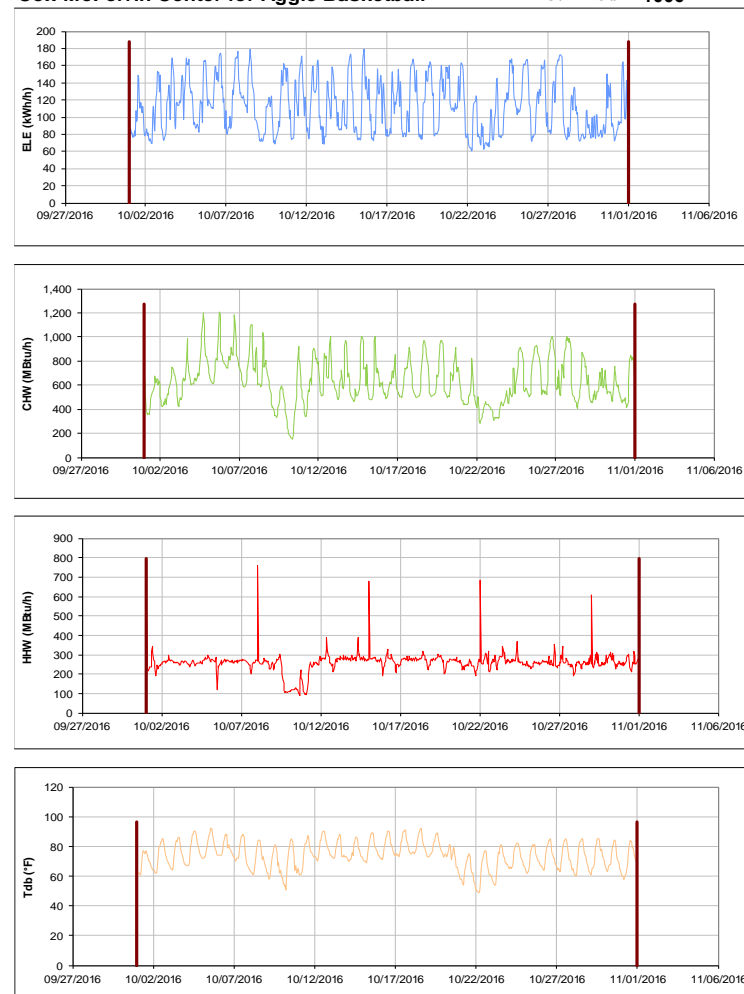
TAMU / BLDG #: 1558

Figure III-170 Hourly Whole Building Electricity, Chilled Water, and Hot Water Consumption for Cox-McFerrin Center for Aggie Basketball during the Month of October 2016 and the Corresponding Hourly Outdoor Dry Bulb Temperature for College Station, TX

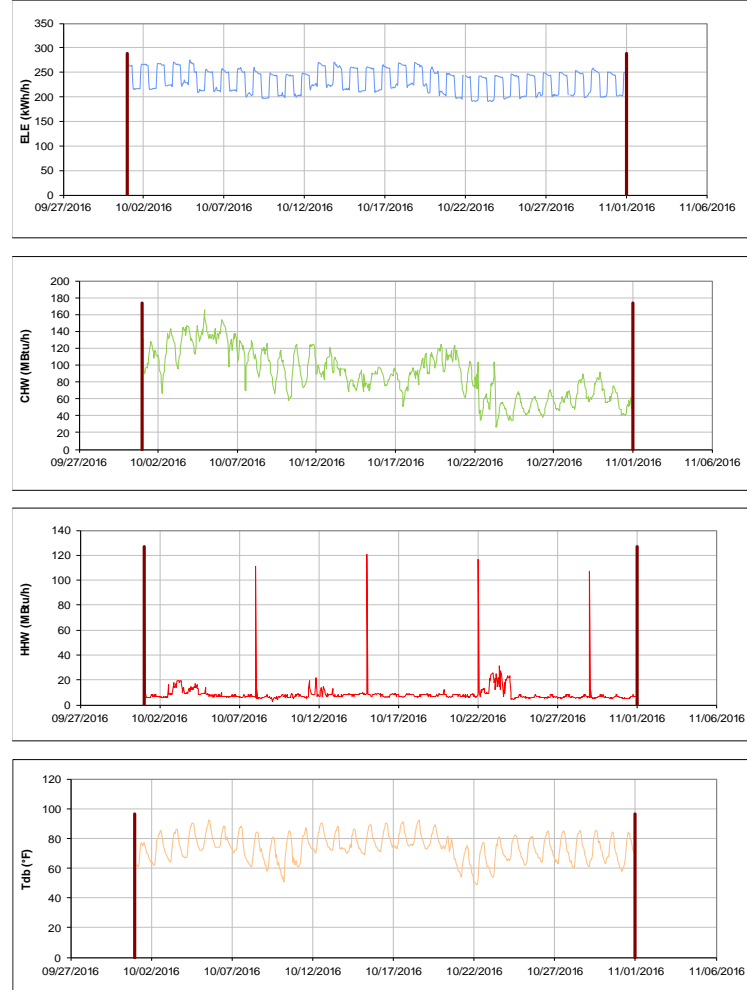
TAMU / BLDG #: 1559

Figure III-171 Hourly Whole Building Electricity, Chilled Water, and Hot Water Consumption for West Campus Parking Garage during the Month of October 2016 and the Corresponding Hourly Outdoor Dry Bulb Temperature for College Station, TX

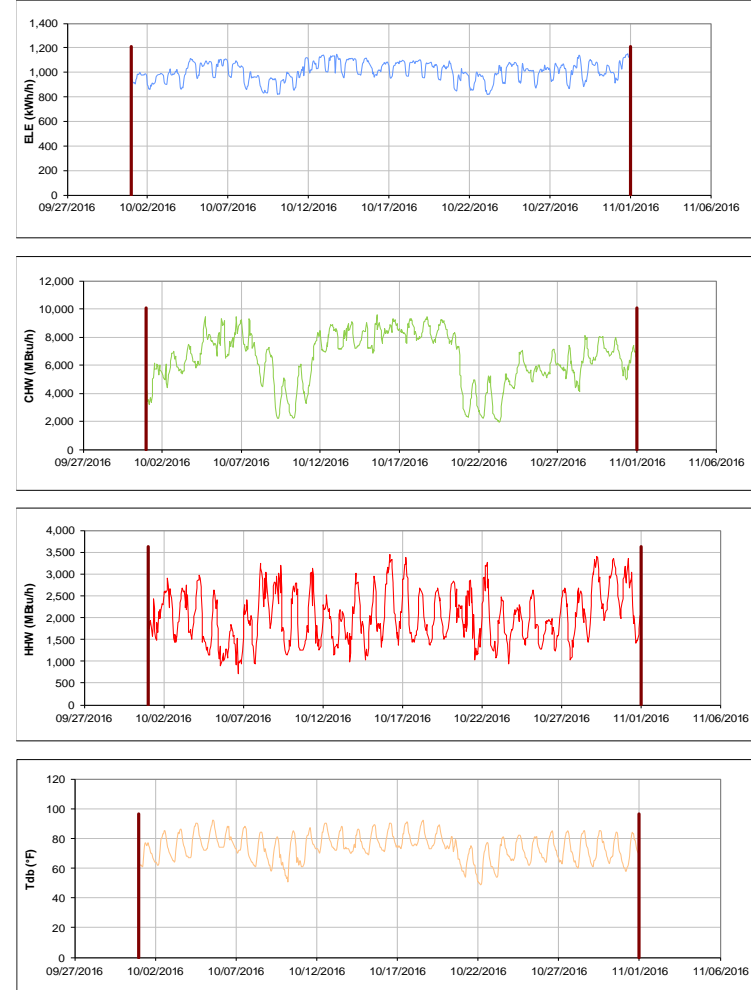
TAMU / BLDG #: 1560

Figure III-172 Hourly Whole Building Electricity, Chilled Water, and Hot Water Consumption for Student Recreation Center during the Month of October 2016 and the Corresponding Hourly Outdoor Dry Bulb Temperature for College Station, TX

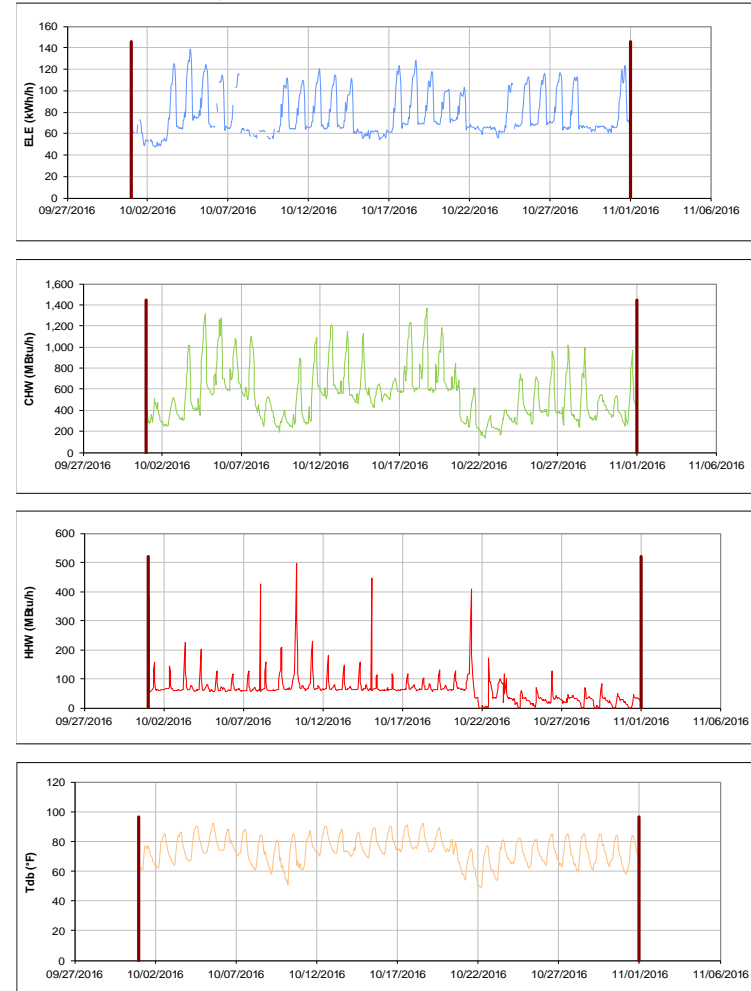
TAMU / BLDG #: 1600

Figure III-176 Hourly Whole Building Electricity, Chilled Water, and Hot Water Consumption for Gilchrist TTI Building during the Month of October 2016 and the Corresponding Hourly Outdoor Dry Bulb Temperature for College Station, TX

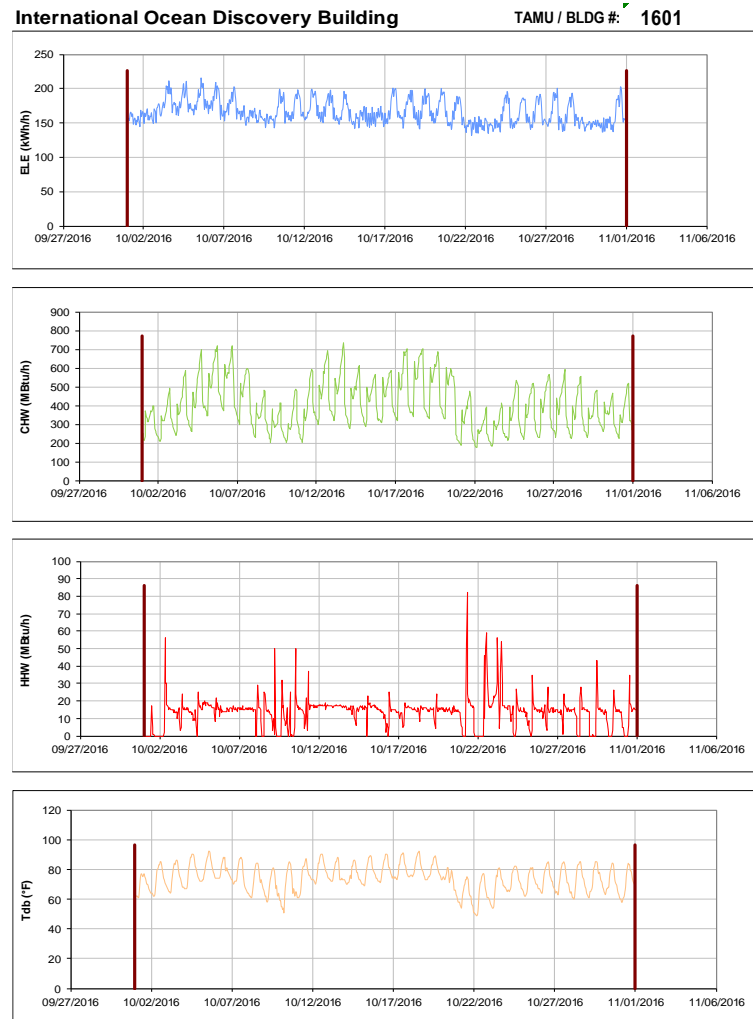
Figure III-177 Hourly Whole Building Electricity, Chilled Water, and Hot Water Consumption for International Ocean Discovery Building during the Month of October 2016 and the Corresponding Hourly Outdoor Dry Bulb Temperature for College Station, TX

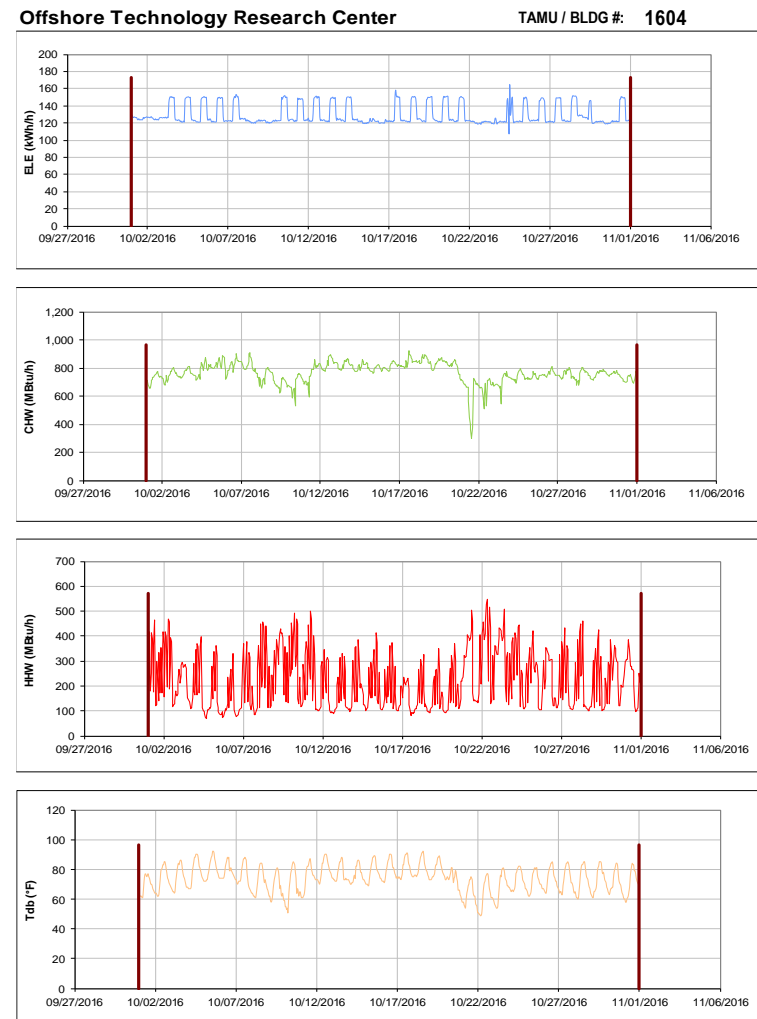
Figure III-178 Hourly Whole Building Electricity, Chilled Water, and Hot Water Consumption for Offshore Technology Research Center during the Month of October 2016 and the Corresponding Hourly Outdoor Dry Bulb Temperature for College Station, TX

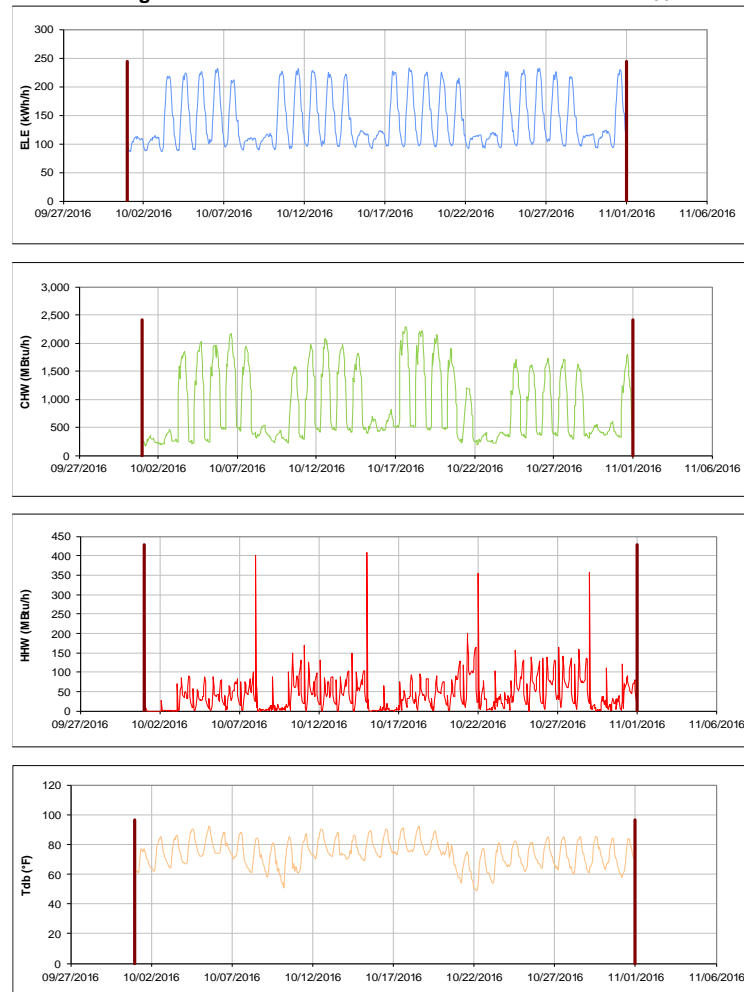
Allen Building TAMU / BLDG #: 1607

Figure III-180 Hourly Whole Building Electricity, Chilled Water, and Hot Water Consumption for Allen Building during the Month of October 2016 and the Corresponding Hourly Outdoor Dry Bulb Temperature for College Station, TX

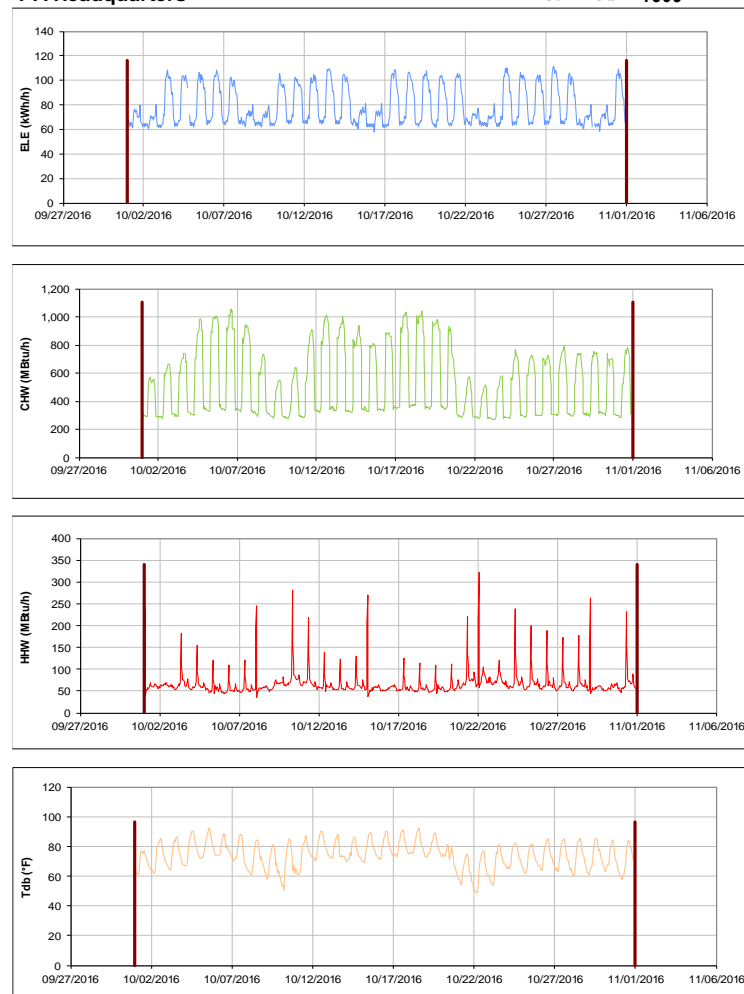
TTI Headquarters TAMU / BLDG #: 1609

Figure III-182 Hourly Whole Building Electricity, Chilled Water, and Hot Water Consumption for TTI Headquarters during the Month of October 2016 and the Corresponding Hourly Outdoor Dry Bulb Temperature for College Station, TX

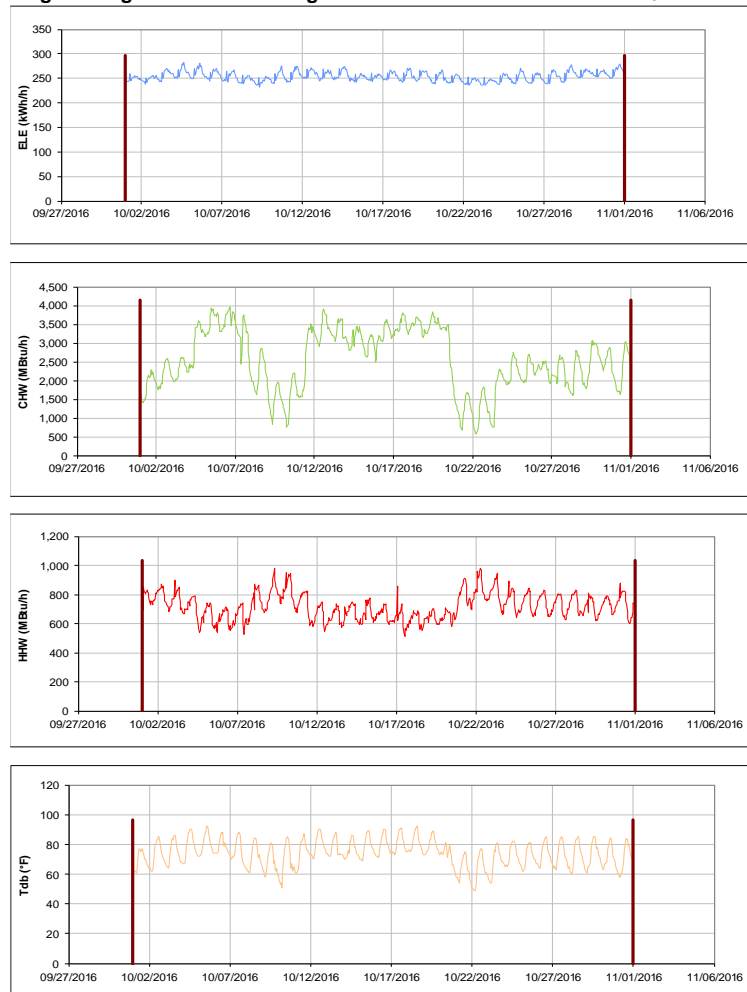
TAMU / BLDG #: 1611

Figure III-183 Hourly Whole Building Electricity, Chilled Water, and Hot Water Consumption for Engineering Research Building during the Month of October 2016 and the Corresponding Hourly Outdoor Dry Bulb Temperature for College Station, TX

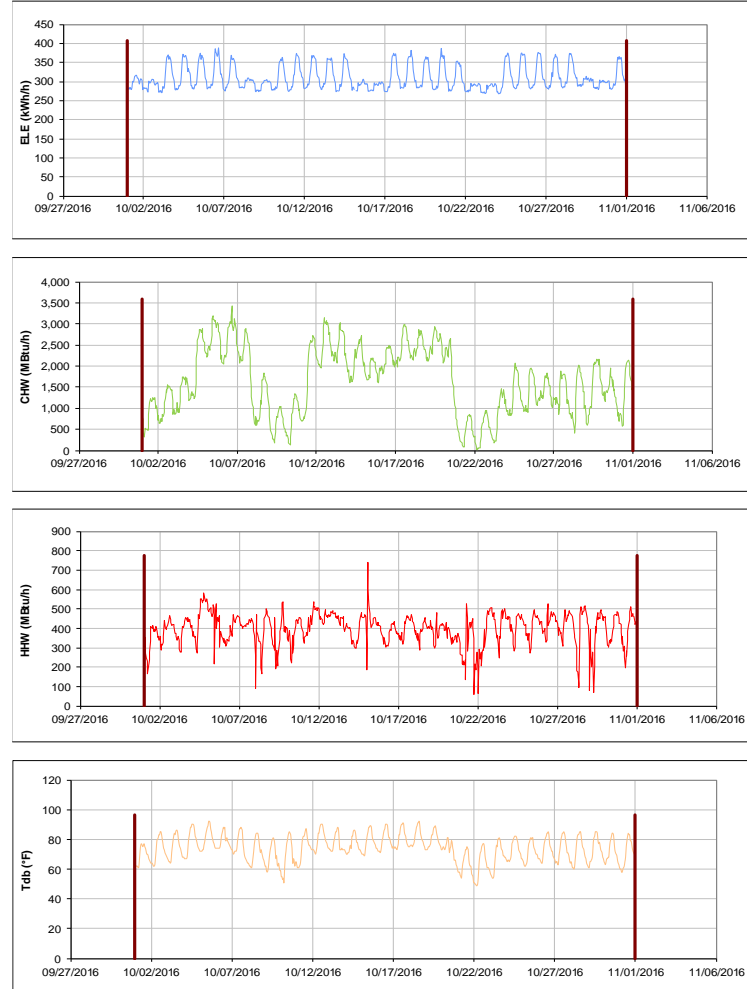
TAMU / BLDG #: 1811

Figure III-187 Hourly Whole Building Electricity, Chilled Water, and Hot Water Consumption for Vet Med Research Bldg Addition during the Month of October 2016 and the Corresponding Hourly Outdoor Dry Bulb Temperature for College Station, TX

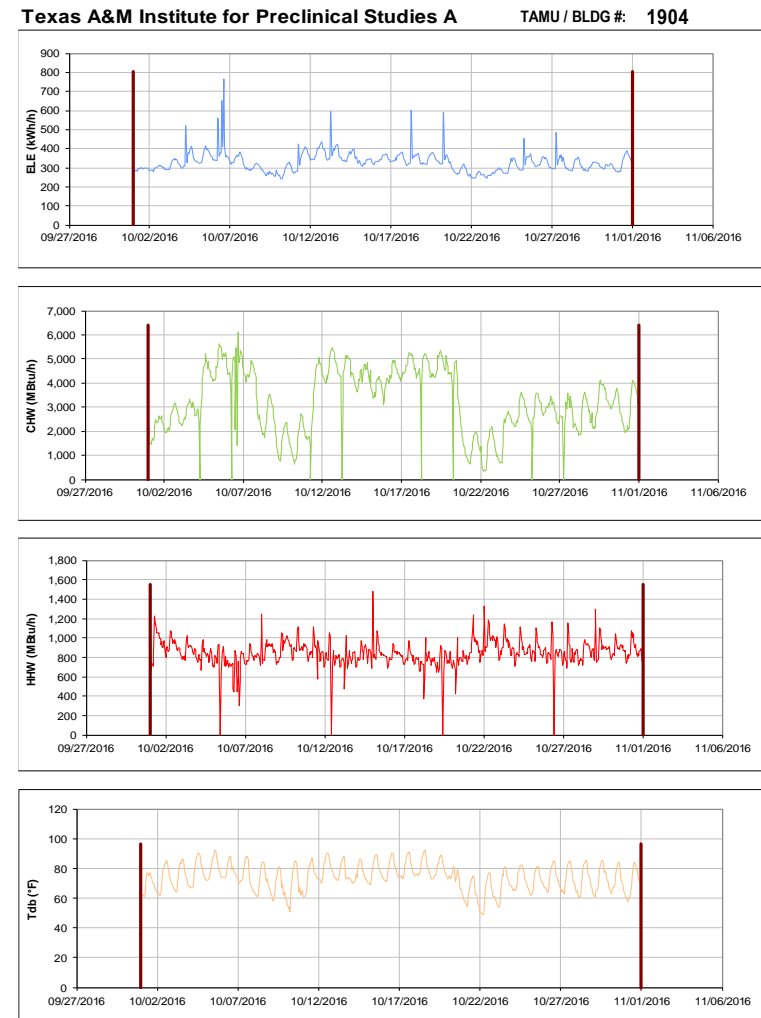
Figure III-190 Hourly Whole Building Electricity, Chilled Water, and Hot Water Consumption for Texas A&M Institute for Preclinical Studies A during the Month of October 2016 and the Corresponding Hourly Outdoor Dry Bulb Temperature for College Station, TX
